# ANNUAL REPORT FOR 2002

**New Light Creek Mitigation Site  
Wake County  
Project No. 8.U401721  
TIP No. R-2000 WM**

Prepared By:  
Office of Natural Environment & Roadside Environmental Unit  
North Carolina Department of Transportation  
December 2002

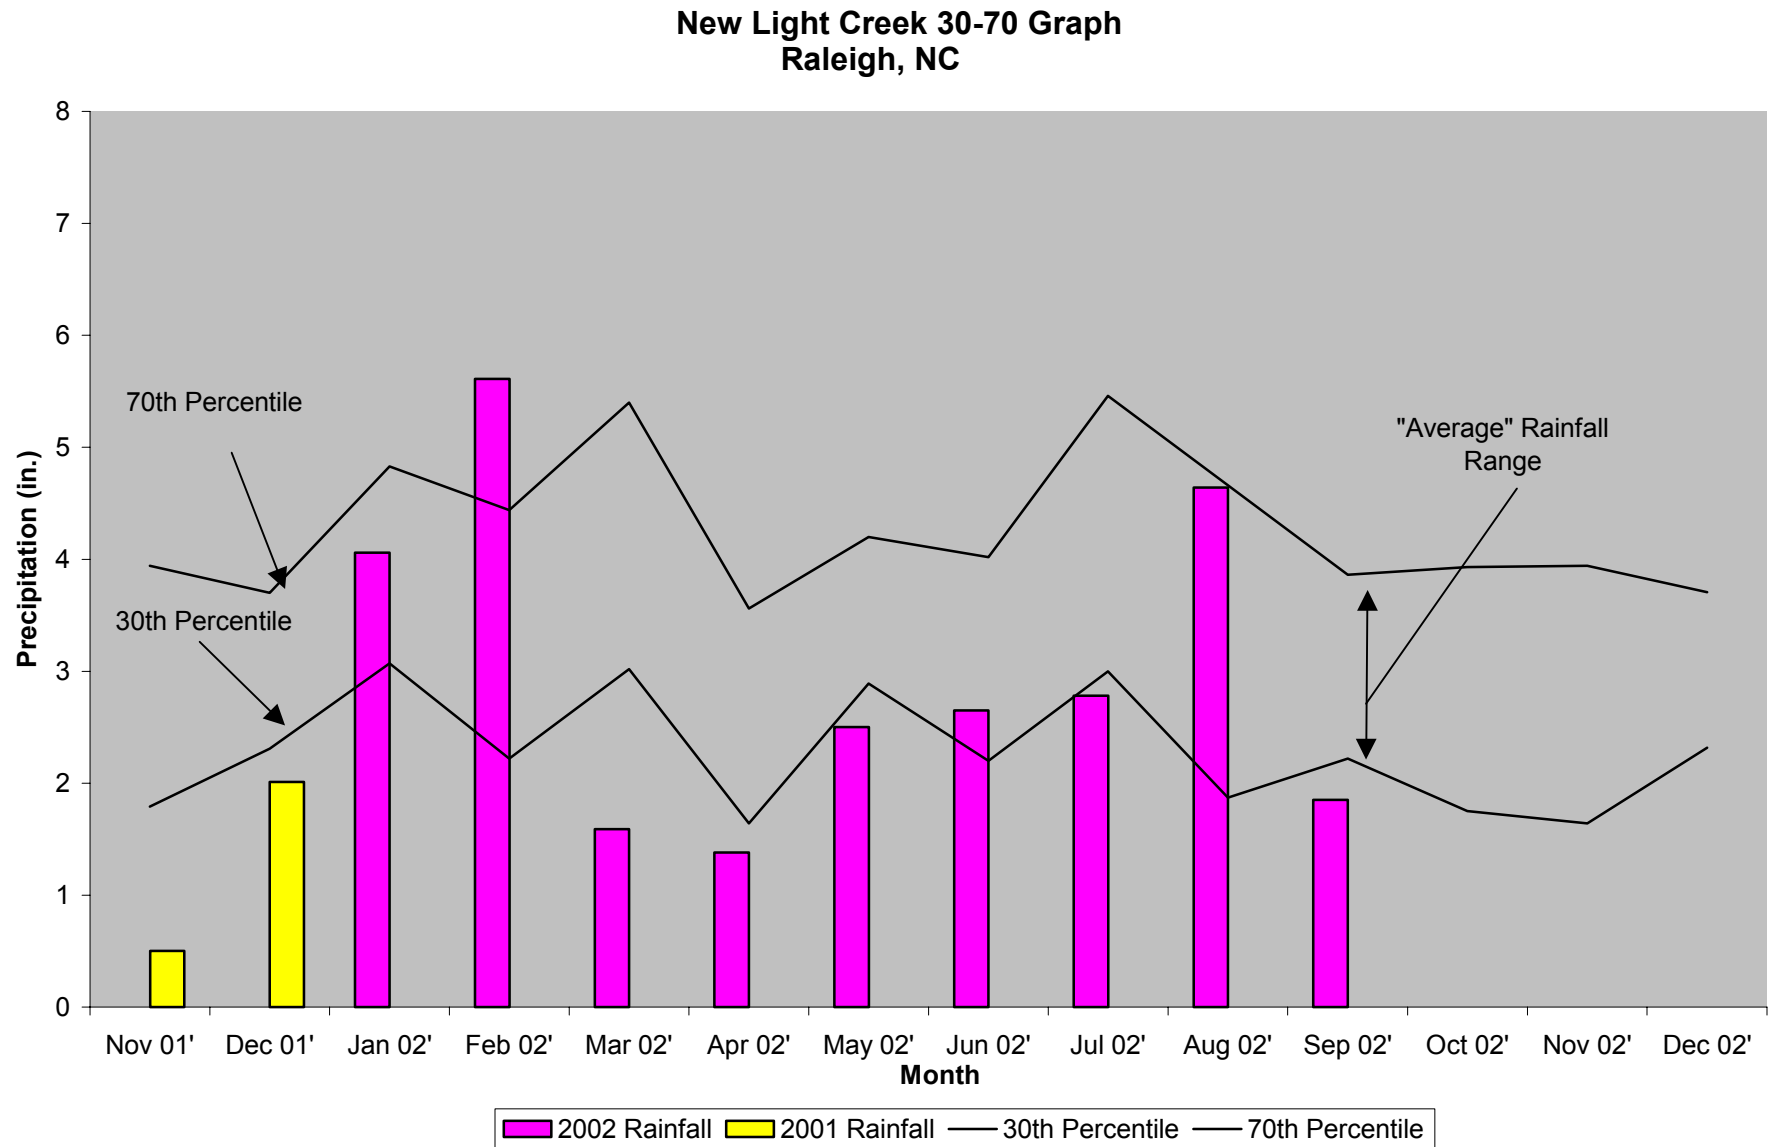
Figure 4.

Figure 4 represents an examination of the local climate in comparison with historical data in order to determine whether 2002 was “average” in terms of climate conditions. The two lines represent the 30<sup>th</sup> and 70<sup>th</sup> percentiles of monthly precipitation for Raleigh. The bars are the monthly rainfall totals for November 2001 through October 2002. The historical data was collected by the NC State Climate Office. Months with below average rainfall include November (2001), December (2001), March, April, May, July, and September. January and August experienced normal rainfall. February experienced above normal rainfall. No data is available for November or December 2002. Overall the site experienced below average rainfall in 2002.

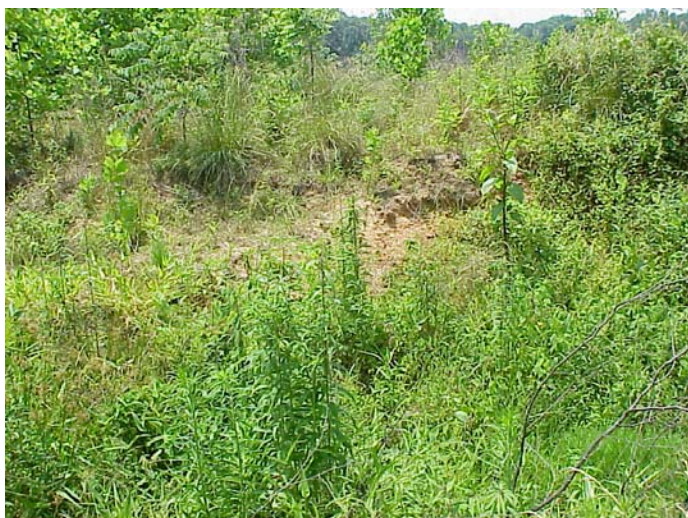
Photo 5

NCDOT and USACE personnel inspected the washout along the streambank in June 2000. It was agreed that NCDOT would repair the washout. This work was not done. A site inspection in September 2000 revealed this washout to be stabilizing on its own. NCDOT has continued to monitor this area to determine if this slope will stabilize given time. The streambank was inspected and photographed during the 2002 monitoring visit and no other signs of erosion were observed (see pictures 5 and 6).
